**CULTURAL RESOURCES INVESTIGATIONS
RELATING TO YUCCA AND AFRICAN HOUSES,
MELROSE PLANTATION (16NA591),
NATCHITOCHES PARISH, LOUISIANA**

Final Report

2014

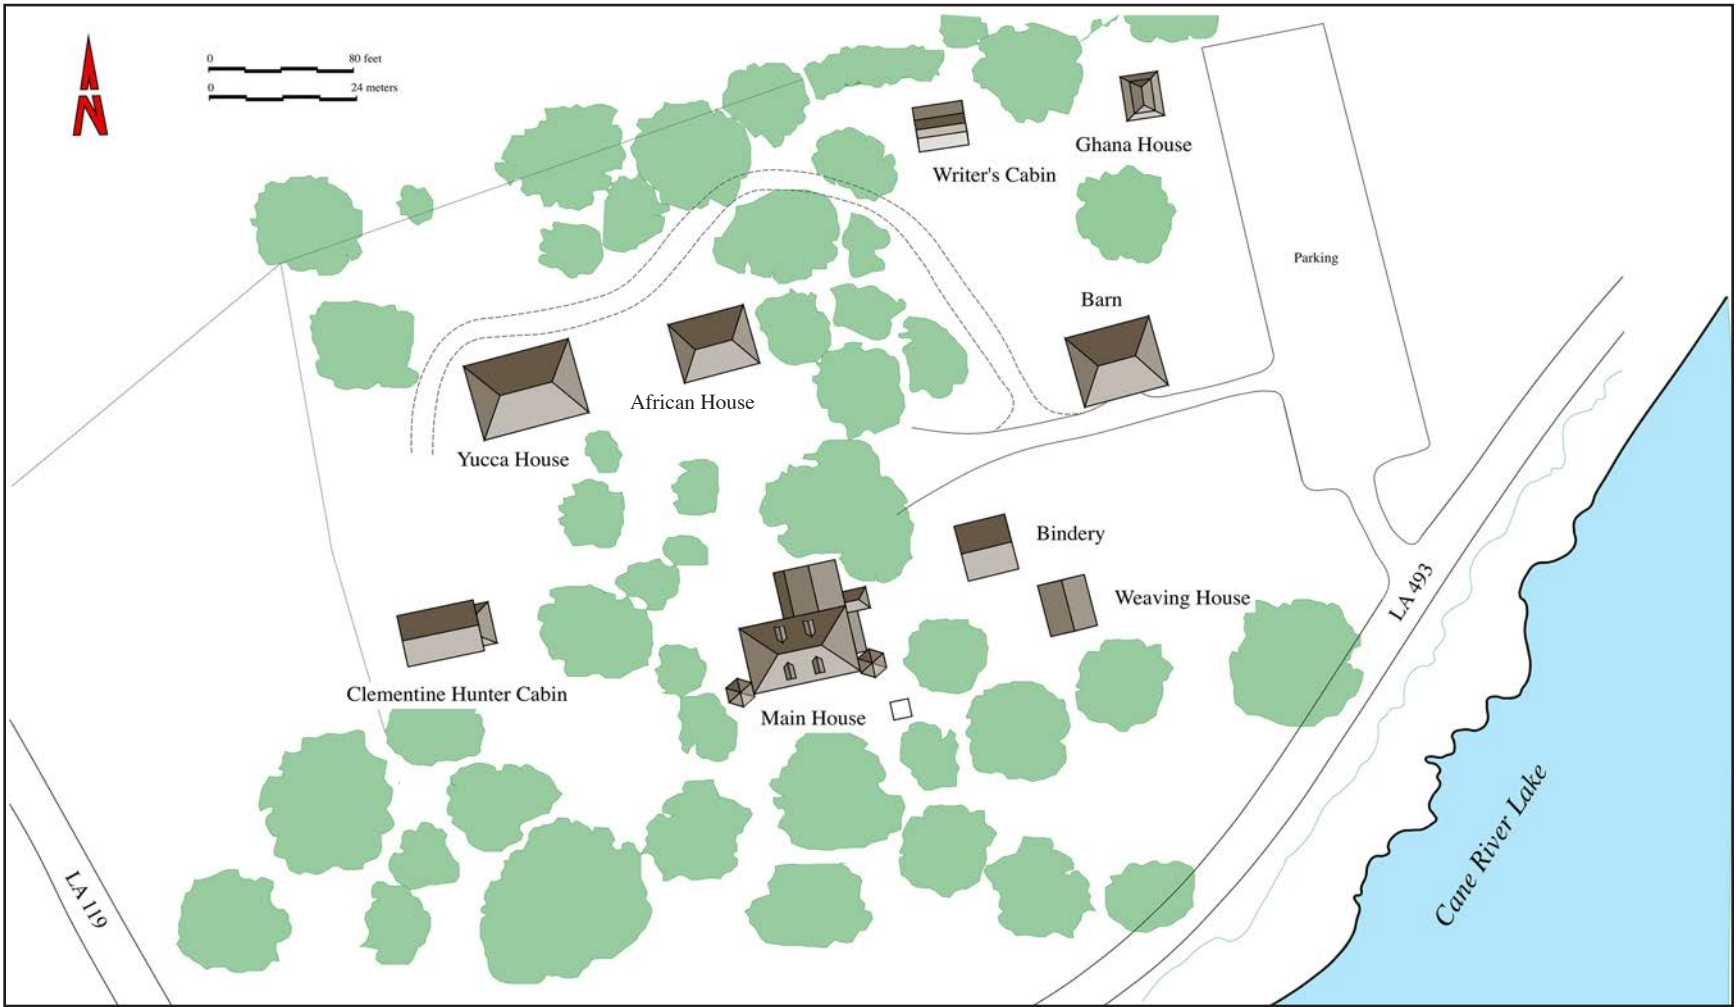
Figure 5.1. A map showing the main buildings associated with Melrose Plantation within the National Historic Landmark boundaries.

There are nine main buildings at Melrose (Figure 5.1). Several of these structures are related to the early history of the plantation and include the main house, Yucca House, African House, and the barn. Other historic buildings are the Writer's Cabin, the Bindery, the Weaving or Loom House, and the so-called "Ghana House," some of which may have been moved on site from elsewhere during the Henry ownership of the property. The current discussion focuses primarily on Yucca House—the center of the current archaeological investigations—and to a lesser extent on African House. The ages of these buildings, the identities of their builders, and historic uses of each have been matters of uncertainty and conjecture for a number of years. An examination of the architecture of Yucca House was made during the 2006-07 investigations to aid in the archaeological interpretations and shed more light on the age of the building, its use, and how the structure was modified through time. This research included an examination of historic photographs of these two architecturally significant buildings.

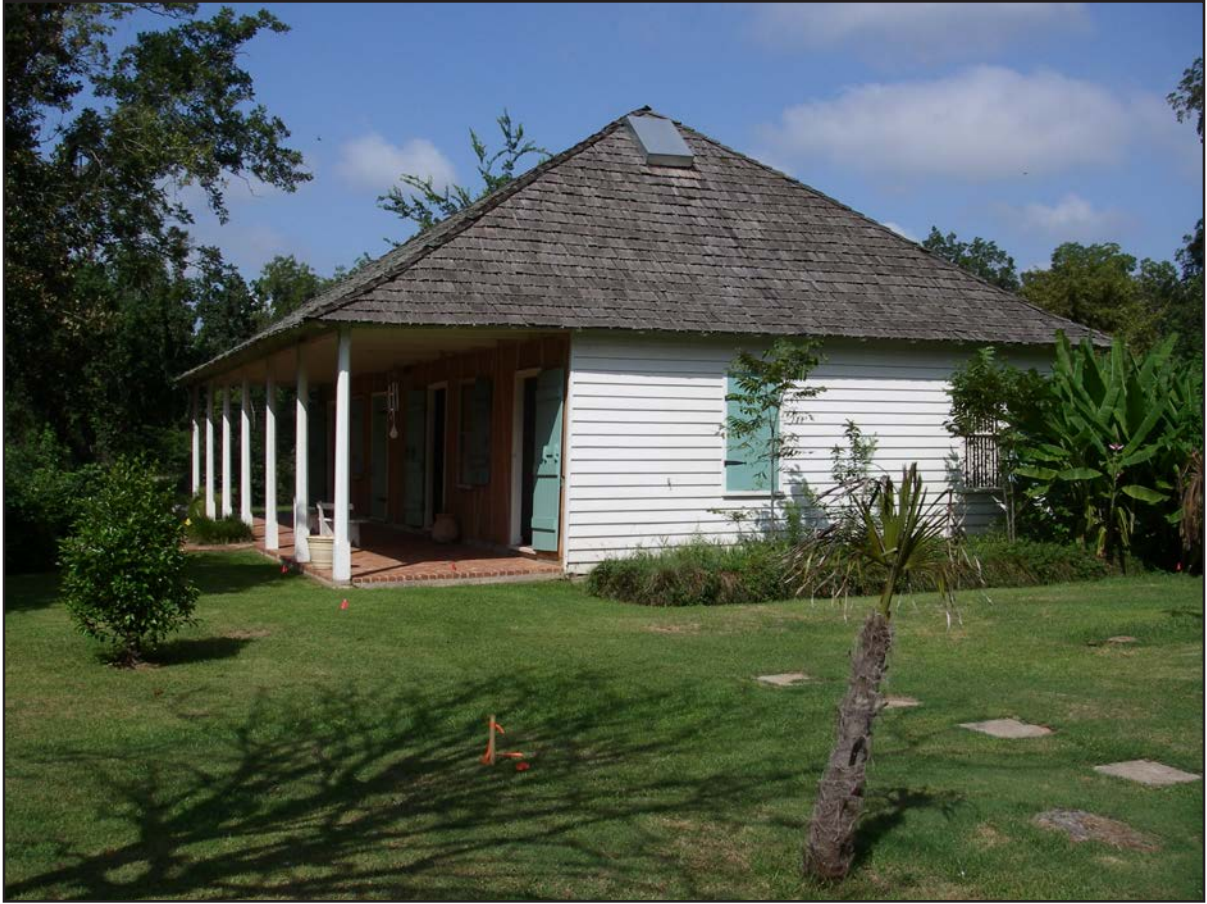
Figure 5.2. A photograph showing the front and eastern side of Yucca House (View is to the west. September 1, 2006.)

Yucca House (Figure 5.2) is a heavy timber-framed structure with mortise-and-tenon joinery connecting the major framing members. It features posts-on-sill construction with *bousillage* between the upright posts of both the interior and exterior walls. Although the sills, in some instances, were either near or resting on the present ground surface, they were actually supported on concrete or sandstone blocks. In 2006, the building had a full-length front gallery

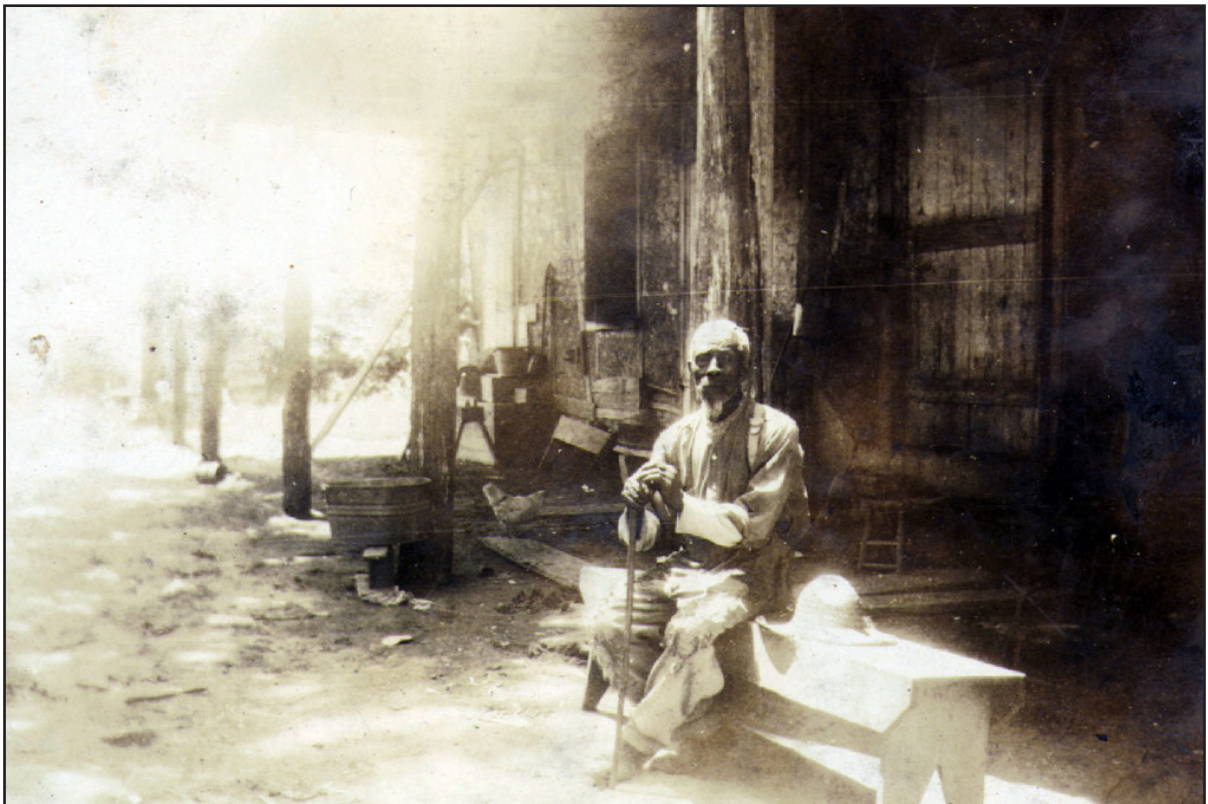
Figure 5.4. Another early photograph showing the front of Yucca House (Date uncertain. CGHRC, Melrose Collection, Folder 1441, p. 1, picture 1.) (This photograph was undoubtedly taken at the same time as the photograph depicted in Figure 5.3.)

Two rather poor-quality photographs (Figures 5.3-5.4) seem to be the earliest depictions of the building. Both show an elderly African American man with a cane seated on a bench in front of the building. A caption on one identifies the individual as “old Uncle Israel Sudduth in Possum Cabin door.” Israel Sudduth was said to have been born in 1825 and had been a slave owned at one time by Hypolite Hertzog. He resided in the building now identified as Yucca prior to Lyle Saxon’s residence there. Joseph M. Henry, Sr., the son of John Hampton Henry and Cammie G. Henry of Melrose, recorded that Saxon moved into Yucca House after the death of Israel Sudduth in 1927 (Folder 1, Joe Henry Collection, Cammie G. Henry Research Center, Eugene P. Watson Memorial Library, Northwestern State University, Natchitoches). However, an article appearing in the March 14, 1926, edition of *The Times-Picayune* indicates that the building was then being used to quarter visiting writers and artists. This would imply that these two photographs date prior to that time. The images show the front of a timber-framed structure, with a massive sill supported slightly above the ground surface on blocks. The floor of the gallery was dirt. The roof of the gallery was supported by posts placed into the ground. The *bousillage* on the front wall was exposed, but displayed traces of whitewash or plaster. Both of the doors and the windows were covered by double-leaf board-and-batten closures.

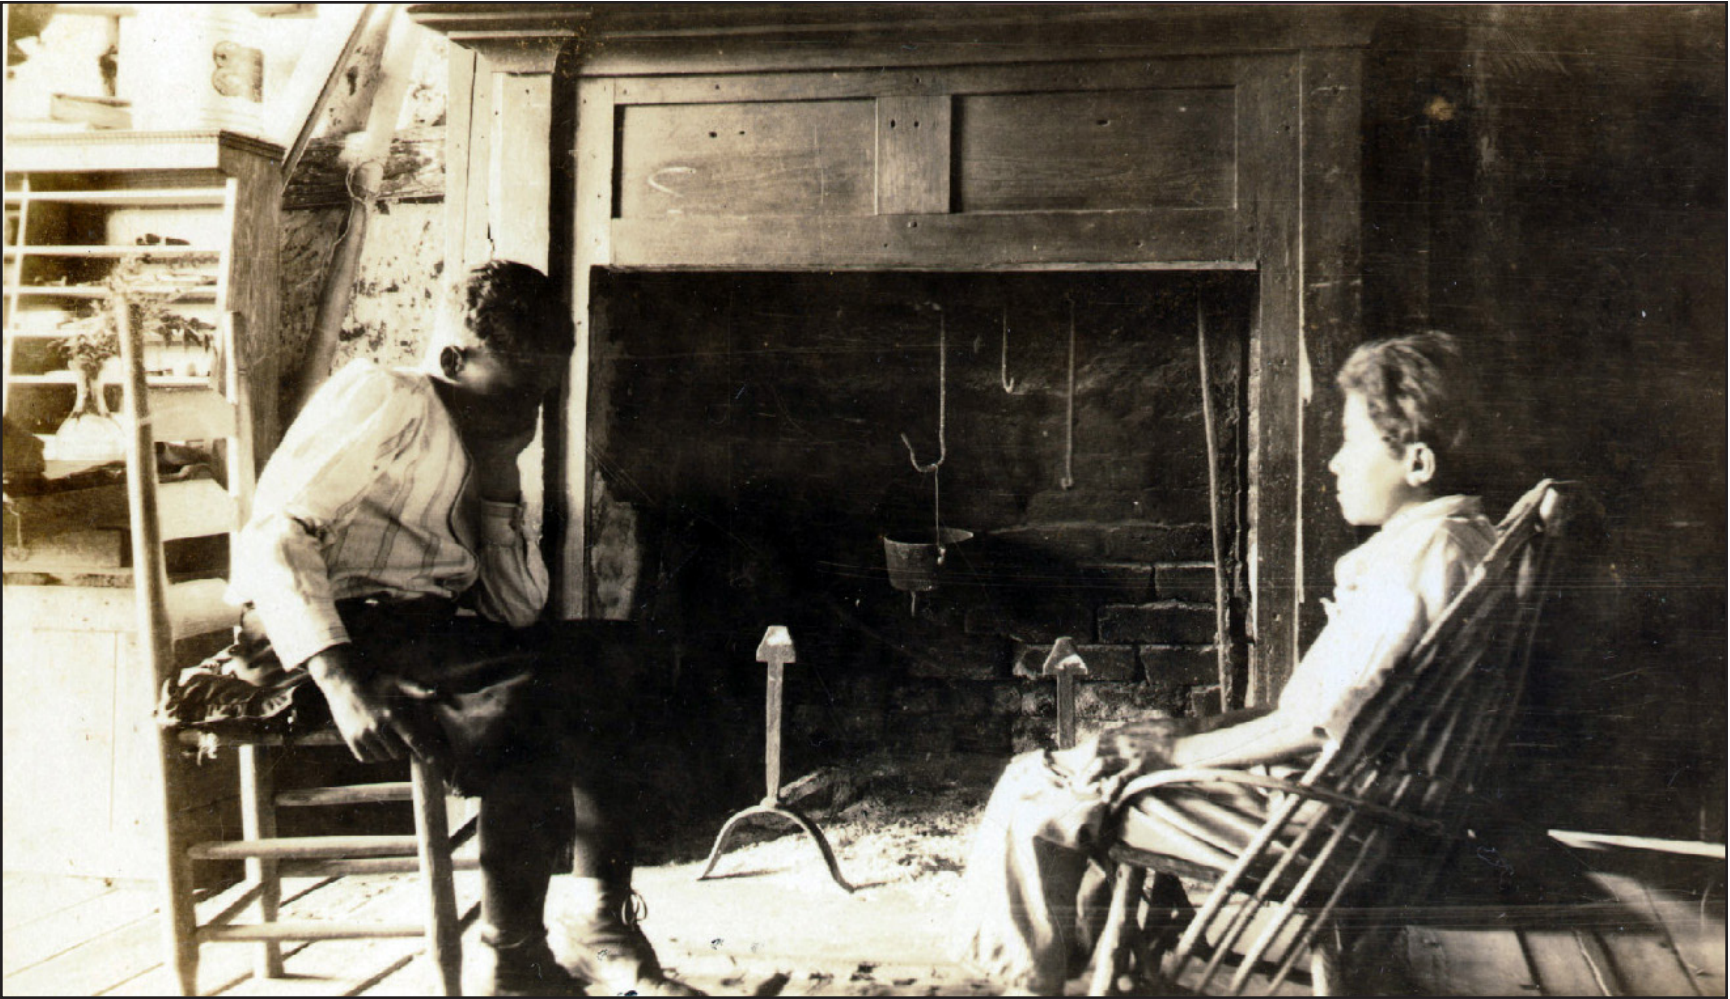
Figure 5.5. An early photograph showing a fireplace hearth in the interior of Yucca House (CGHRC, Melrose Collection, Scrapbook 200, p. 3.) (Date uncertain. Note that the small cast iron kettle is of a type in common use in the late eighteenth and early nineteenth centuries.)

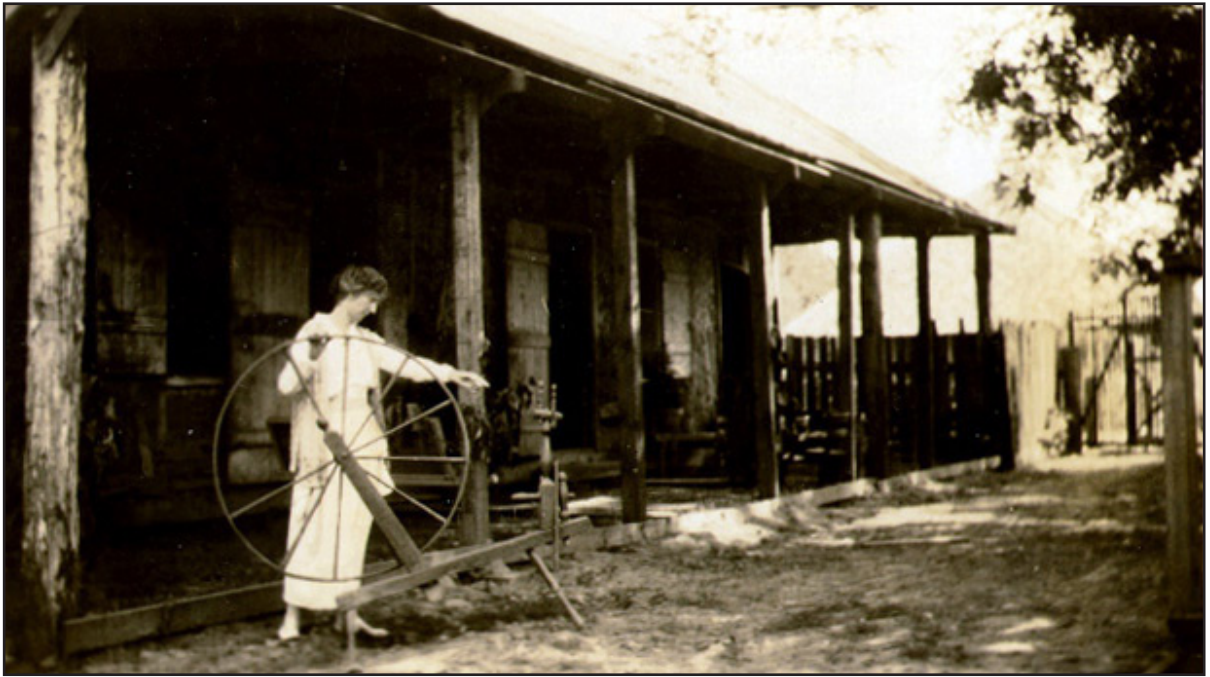
Figure 5.6. A ca. 1924 photograph showing noted southern artist Edith Fairfax Davenport with a spinning wheel in front of Yucca House (GCHRC, Melrose Collection, Scrapbook 220, p. 2, photograph 3).

several square replacement posts supporting the front gallery roof, and boards placed at ground level that connect the bottoms of the front gallery posts. The lapped cypress gutters (Figures 5.6-5.8) ran along the front of the gallery roof line and drained to the west into a below-ground brick cistern. The windows had closely spaced vertical bars (see Figures 5.7, 5.9), evidently to prevent entry but allow air circulation. One of the photographs presumed to be associated with this group (Figure 5.10) shows a window with double-leaf “shutters,” each containing two vertical panes of glass. The hinges on these “shutters” appear to be relatively modern and were obviously additions to the original building. That same photograph shows the exposed front *bousillage* wall with residual plaster or whitewash. What appears to be a board running horizontally between the lower ends of the heavy timber wall framing members is actually a shallow shelf or bench. The massive sills supporting the walls were shown elevated just above ground level (see Figures 5.10-5.11). The floor of the front gallery remained packed earth.

Several photographs in this group show that the doorways had single-leaf board-and-batten doors that opened outward (see Figures 5.6-5.7, 5.9). None had screen doors to prevent insects from entering the dwelling. One of these photographs shows thin wooden laths nailed horizontally between the front gallery posts that were used as a simple trellis to support what appear to be grape vines (see Figure 5.11).

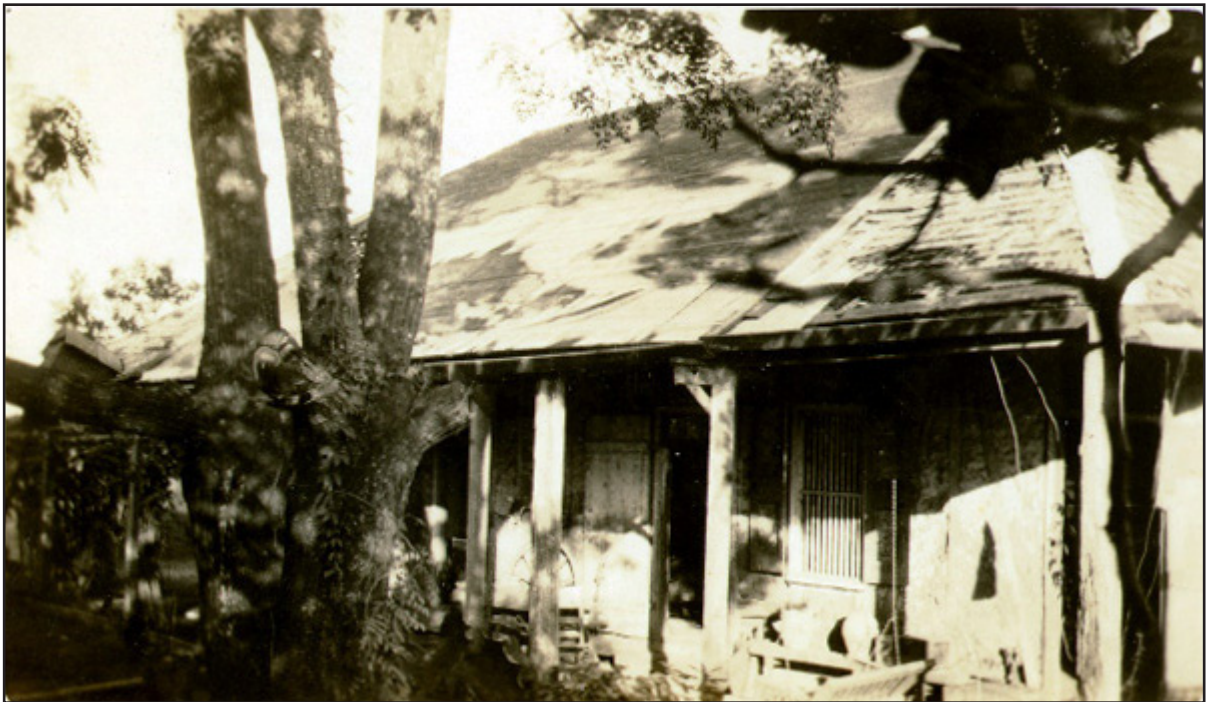
Figure 5.7. An undated photograph showing the front of Yucca House (GCHRC, Melrose Collection, Scrapbook 220, p. 2, photograph 2).

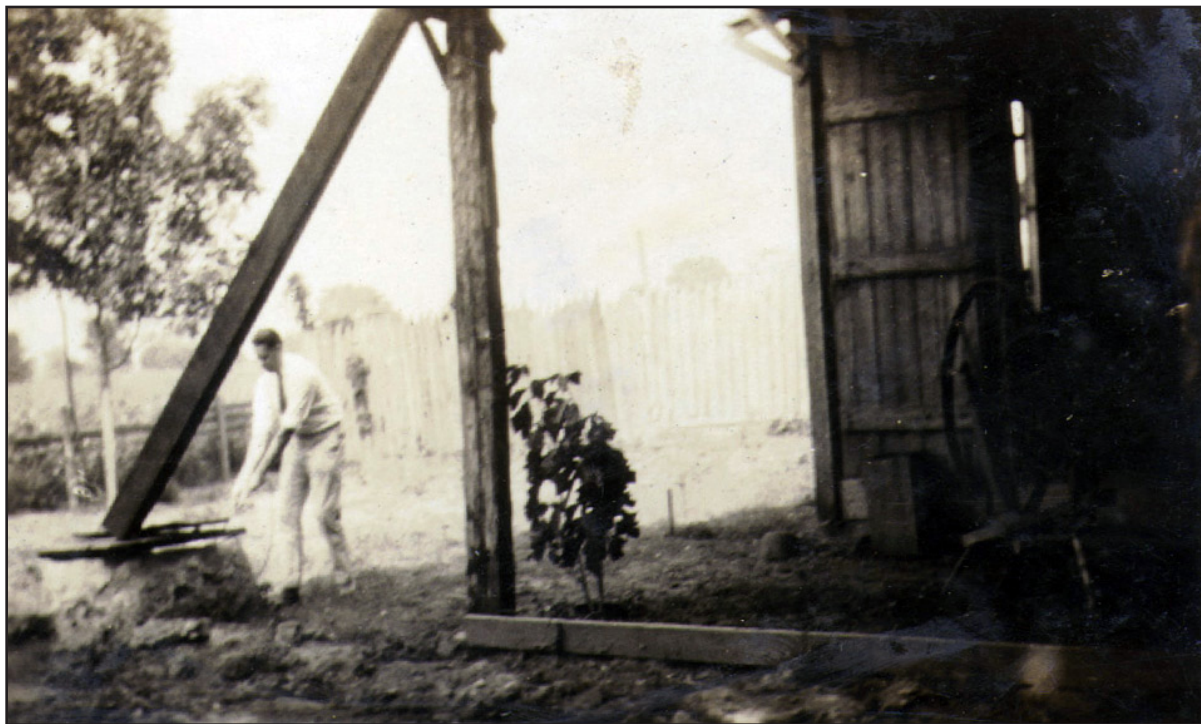
Figure 5.8. (Above) A ca. 1925 photograph showing writer Lyle Saxon at the below-ground brick cistern beside Yucca House (CGHRC, Melrose Collection, Folder 1441, p. 3, photograph 2).

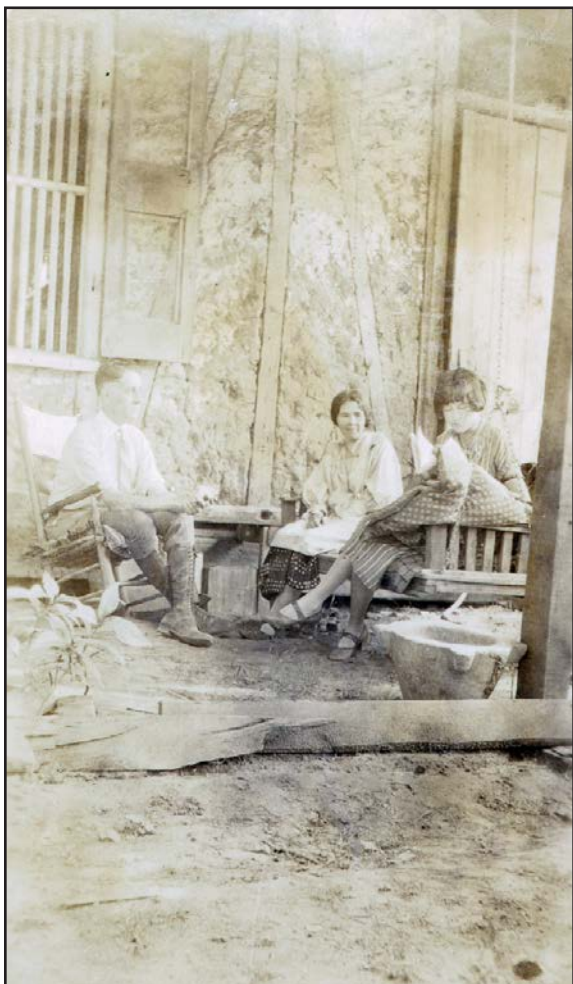
Figure 5.9. (Left) A ca. 1925 photograph showing writer Lyle Saxon, Alberta Kinsey, and Ada Jack Carver in front of Yucca House (CGHRC, Melrose Collection, Scrapbook 83, p. 63, photograph 1).

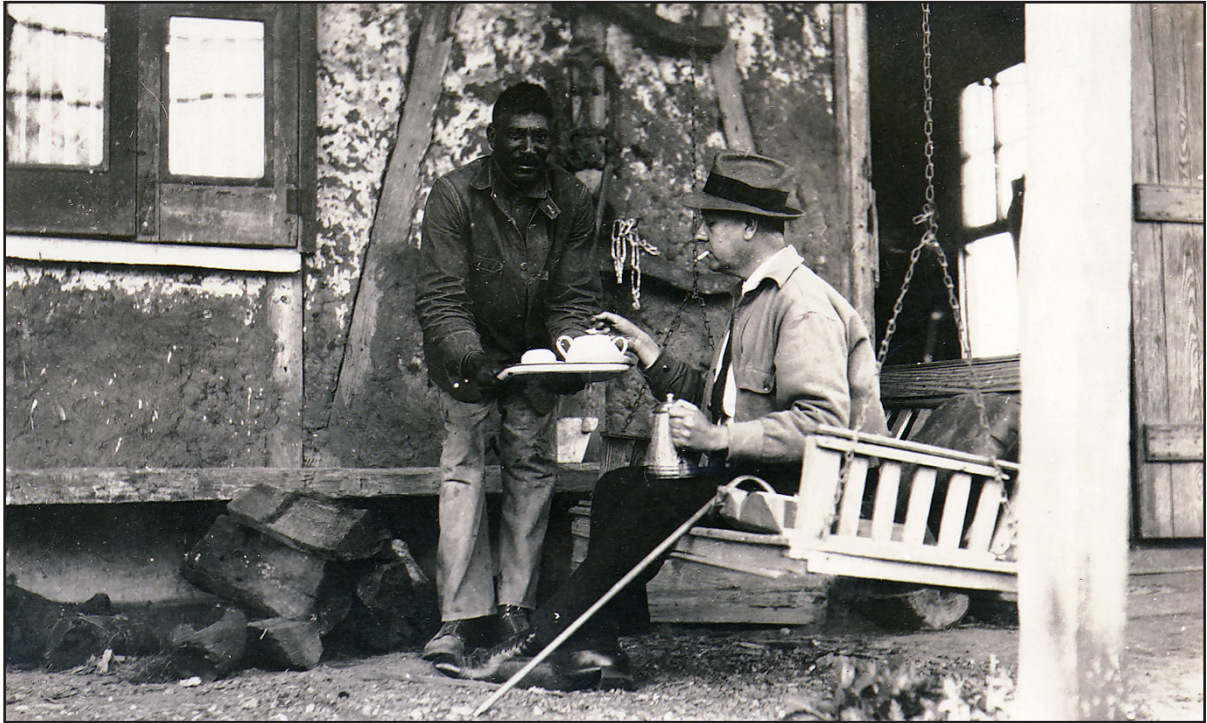
Figure 5.10. An undated photograph showing the front of Yucca House (GCHRC, Melrose Collection, Unprocessed Folder 2).

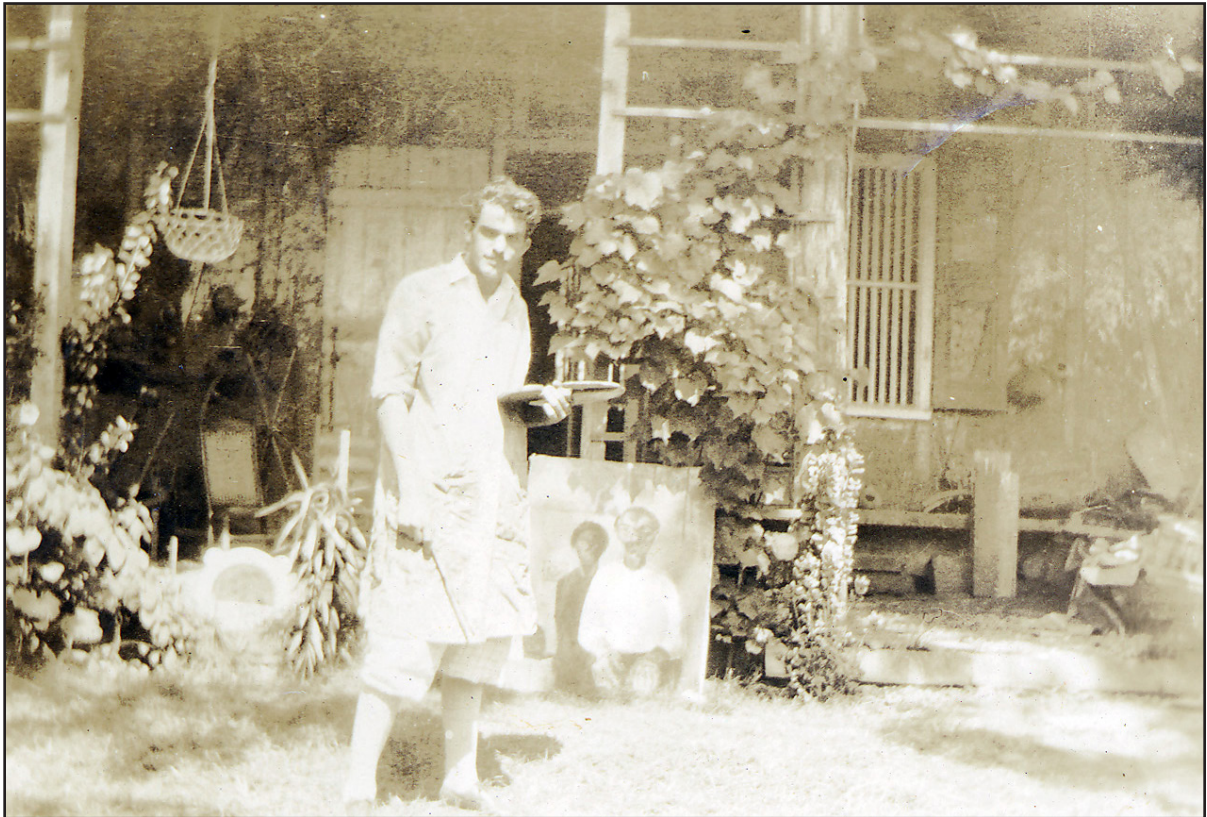
Figure 5.11. An undated photograph showing an artist believed to be Edward Howard Suydam painting in front of Yucca House (GCHRC, Clementine Hunter Collection, Folder 11).

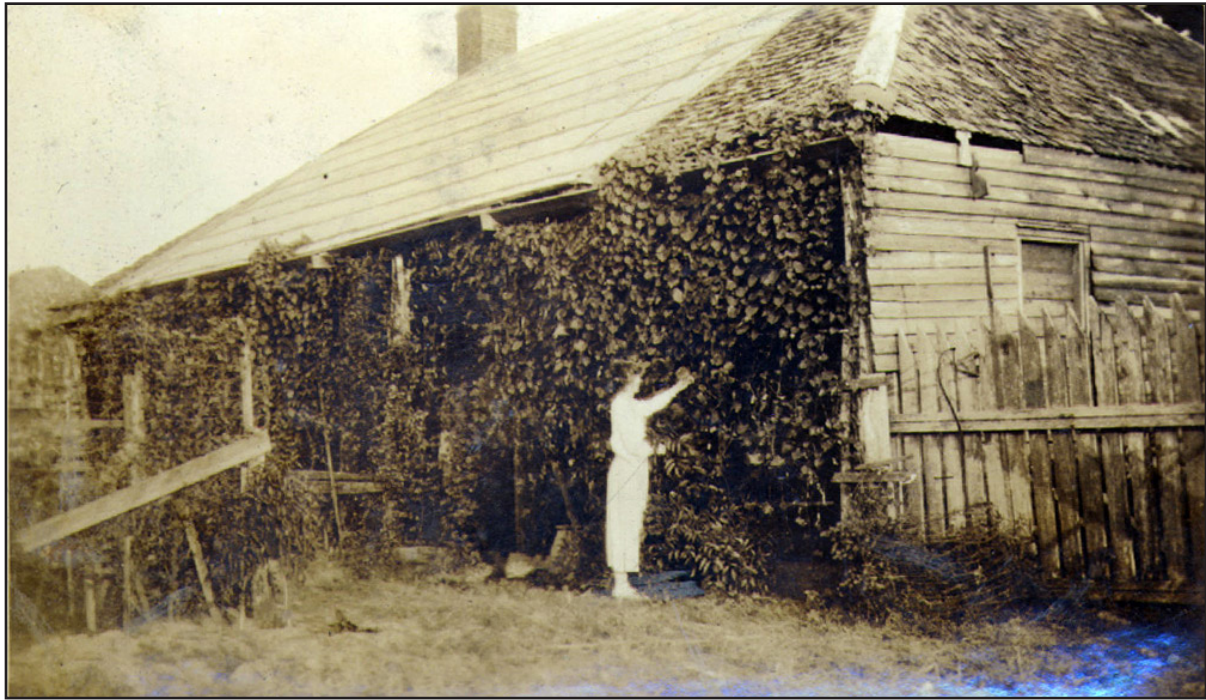
Figure 5.12. A ca. 1924 photograph showing Edith Farifax Davenport “training morning glories at the Back of Possum Cabin” (GCHRC, Melrose Collection, Folder 1441, p. 2, photograph 5).

Only one of the photographs in this second group shows the rear of the building (Figure 5.12). Morning glories growing up the northern side of the structure obscure many of the architectural details. V-shaped cypress gutters also ran along the northern roofline and undoubtedly once emptied into the cistern near the southwest corner of the house. The western exterior *bousillage* wall was covered by cypress lap siding, and there was a cased opening in the western wall of the southwestern *cabinet*. The picket fence in the photograph prevents seeing whether that opening was a door or a window.

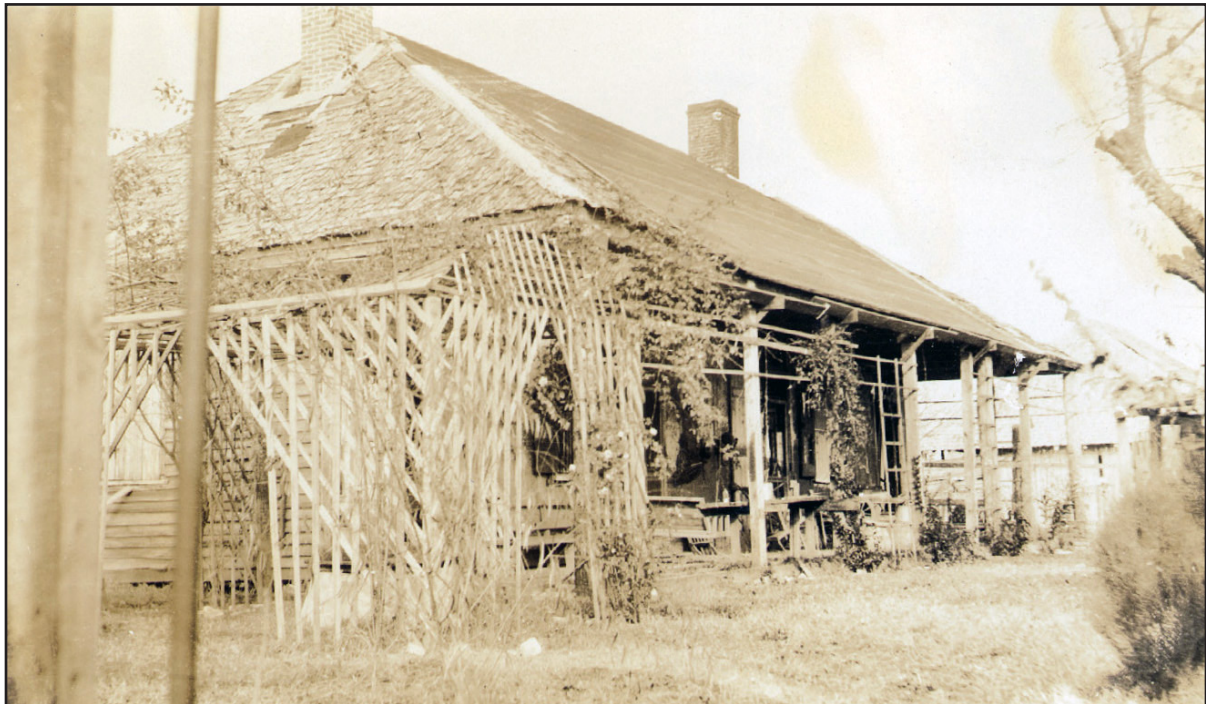
Figure 5.13. A photograph showing the front and western side of Yucca House (GCHRC, Melrose Collection, Folder 1441, p. 2, photograph 5). (Note: the photograph bears the date of 1921, which is believed to be inaccurate.)

A window is, however, clearly depicted on the western wall of the house in another photograph that is, perhaps, slightly later. The image (Figure 5.13) has a date of 1921, although that seems unlikely. The fact that it is related to this particular group of photographs lies in the condition of the roof and the presence of the cypress gutters. The elements that suggest it is somewhat later than the others include the latticework surrounding the cistern in the foreground and the simple

wooden horizontal trellis members running between the posts supporting the roof along the front gallery. Additionally, there is no picket fencing along the eastern end of the house, an element that was clearly evident in several of the other images (cf., Figures 5.3, 5.6).

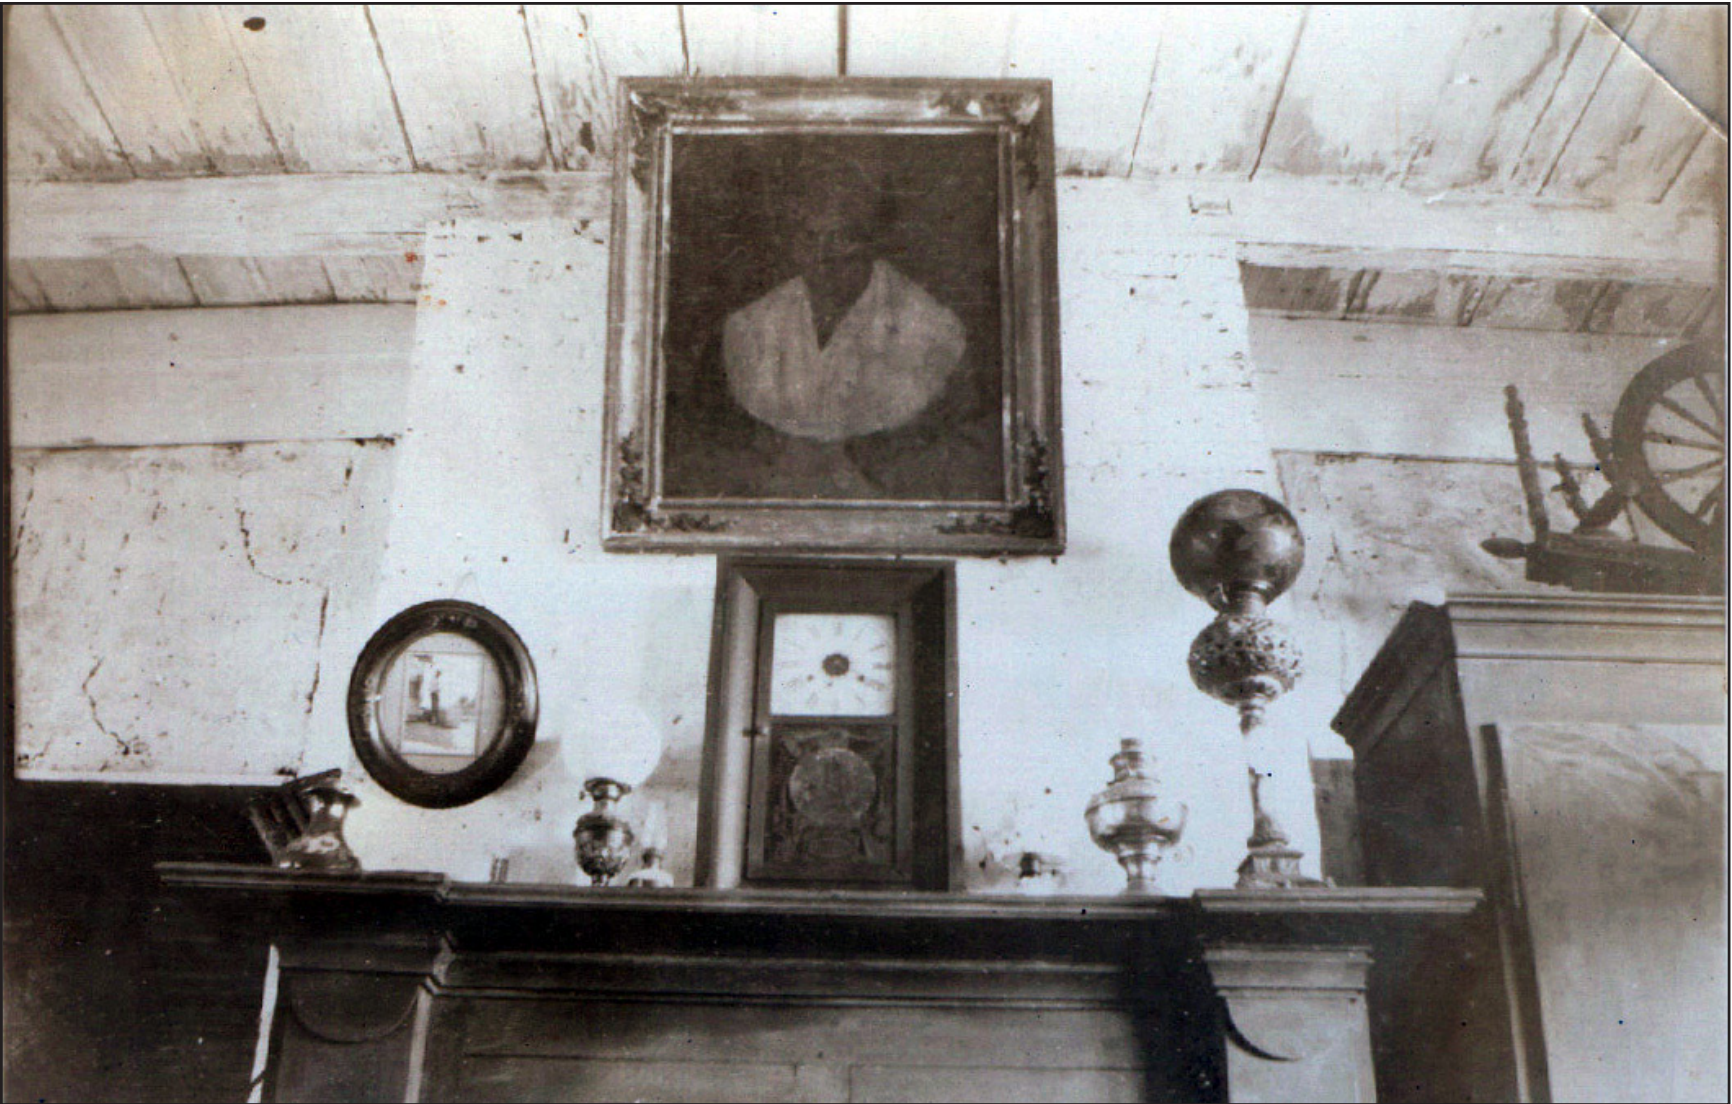
Figure 5.14. An undated photograph showing the fireplace mantle in Lyle Saxon's room in Yucca House (GCHRC, Melrose Collection, Scrapbook 79, p. 115, photograph 2).

There are several images that depict the interior of the building during this general time period. Perhaps one of the earliest (Figure 5.14) shows another wooden mantle, more elaborate than the one discussed above. It supports a clock and is surmounted by a woman's portrait hung just below ceiling. The clock and the portrait occur in subsequent photographs depicting what was identified as Lyle Saxon's room. One (Figure 5.15) has three boys sitting in chairs in front of the fireplace. The mantle clock and small oval framed image shown in Figure 5.14 also occur in this photograph. Although somewhat difficult to discern, the fireplace has hangers for cooking pots, and part of a small, three-legged kettle can be seen in the background between the center boy's knees. These features substantiate that the fireplace appearing in photographs Figure 5.14 and Figure 5.16 are one in the same. In the latter image (see Figure 5.16), the pots, hangers, and fireplace tools can be plainly seen. In both photographs, the floor consists of planks, some of which had fairly wide gaps between one another.

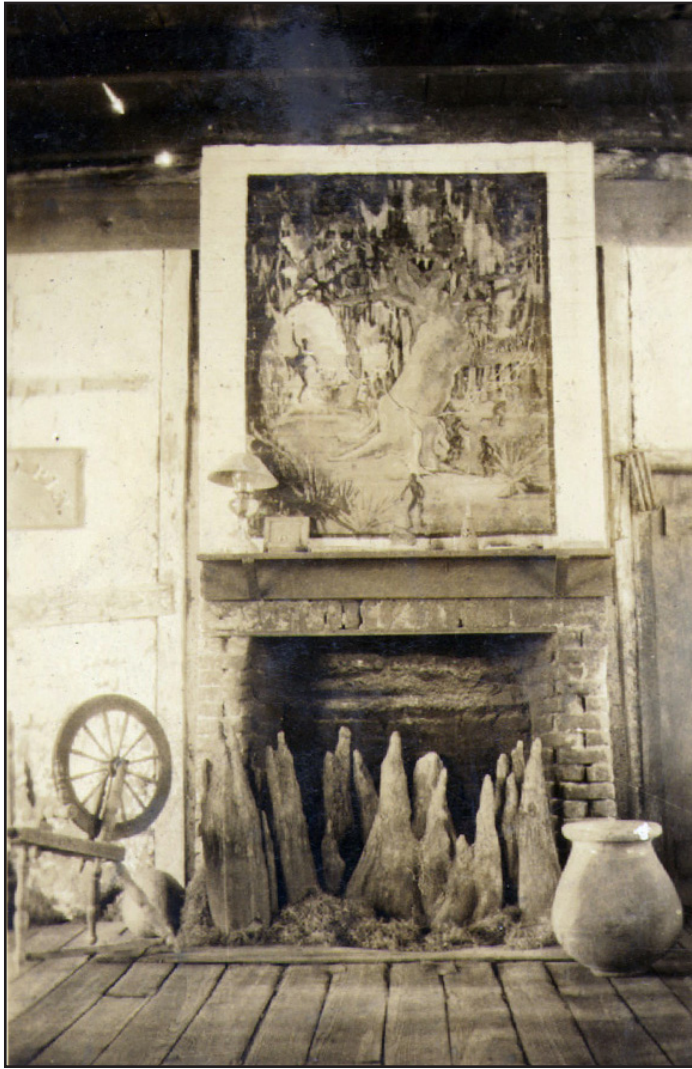
Figure 5.17. A ca. 1925 photograph showing the second fireplace in Yucca House (CGHRC, Melrose Collection, Folder 1441, p. 2, photograph 3). (The painting is believed to have been the work of Edward Howard Suydam).

One of the photographs included in this group (Figure 5.17) shows another fireplace, evidently in a different room. There is a small shelf-like mantle over the hearth that supports a large painting, possibly one done by Edward Howard Suydam. The brick hearth is filled with cut cypress knees and Spanish moss used for decoration. A spinning wheel is to the left of the hearth, and a yellow-glazed coarse earthenware jar is to the right. Although the *bousillage* walls were painted or whitewashed, the ceiling boards and joists were unpainted. Here again, the flooring consisted of wooden planks. This was possibly the room occupied by Suydam during his tenure at Melrose.

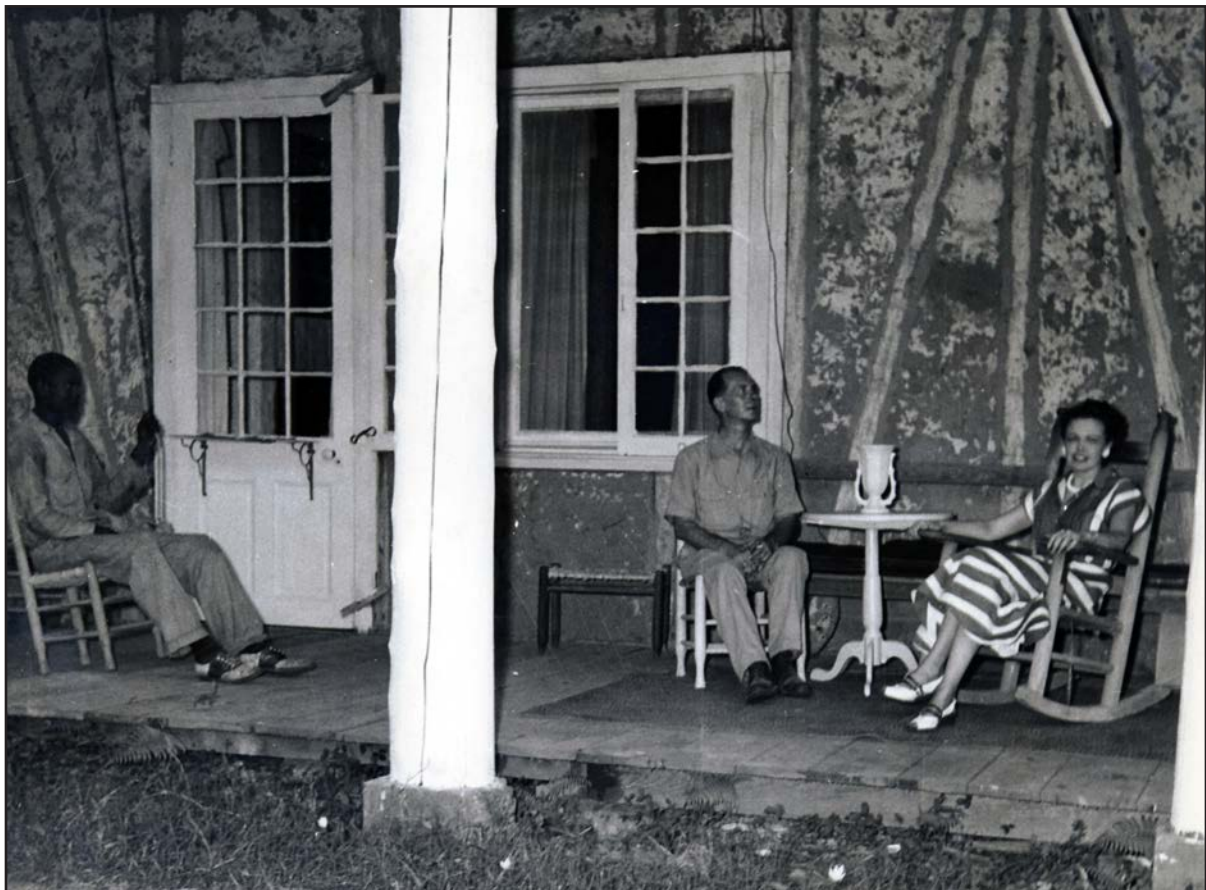
Figure 5.27. An undated photograph showing François Mignon and two unidentified individuals sitting on the rear gallery of Yucca House (CGHRC, François Mignon Collection, Folder 106).

Two other photographs depicting the rear of the house appear to date to the late 1940s. Both show the rear of the building with François Mignon seated with an unidentified woman on the rear *loggia* (Figures 5.27-5.28). These images illustrate that by then the floor of the *loggia* was made of wooden planks supported by wooden joists resting just above the ground level. The outer edge of the roof along the *loggia* was supported by six wooden tree trunks used as posts set in concrete. The outer wall of the house beneath the *loggia* was unpainted *bousillage* with traces of residual whitewash or paint. There were two doors, each entering one of the two larger interior rooms. These doors were single panels with 15 lites of window glass. Each of the two windows had double panels, each panel having 10 glass lites. The *cabinets* flanking the *loggia* on each of its ends were covered with cypress board-and-batten siding. It is presumed that the siding protected underlying *bousillage* walls. Bi-fold louvered shutters entered each of the *cabinets* from the *loggia*, and each *cabinet* had double louvered doors on their outer walls. There was a hand-pulled *pankha* under the *loggia* that served as a crude ceiling fan. The photograph presented as Figure 5.28 shows a recently erected sundial in the yard to the north of the house. This photograph evidently dates to 1949, as a copy of it appeared in the November 27, 1949, edition of *The Times-Picayune* (*The Times-Picayune* 1949:182).

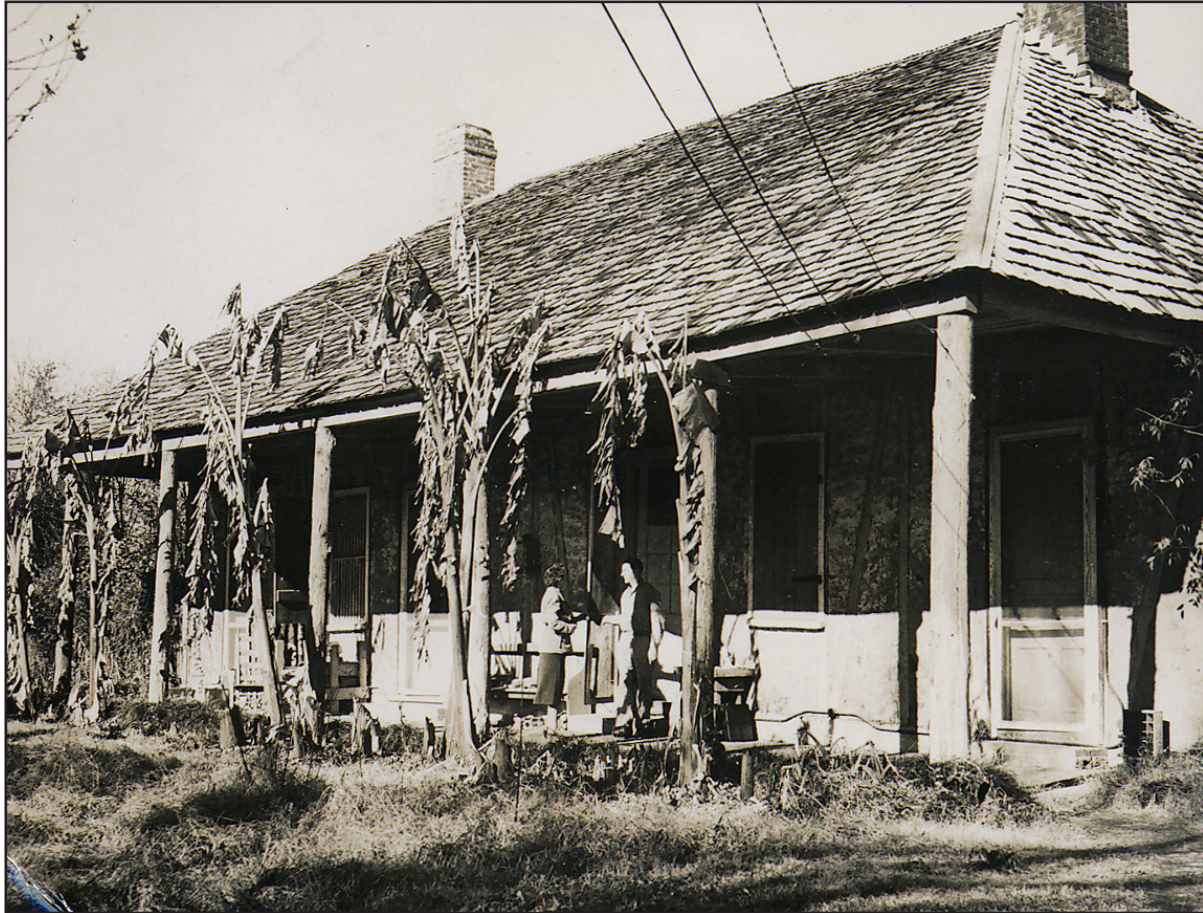
Figure 5.29. (Above) An undated photograph showing the front of Yucca House (CGHRC, François Mignon Collection, Folder 101). (François Mignon and an unidentified woman are on the gallery.)

The two late 1940s photographs described above that show the rear of the house appear to have been taken at the same time as two depicting the front of the structure. The first (Figure 5.29) shows François Mignon with the same woman standing on the front gallery. This image illustrates many of the same features seen on the 1940 HABS photograph (see Figure 5.24) discussed above. The shutters on one of the windows are open, revealing that the wooden bars seen in earlier photographs remained in place. The banana plants growing along the gallery and the arrangement of some of the items along the front wall indicate that the second photograph (Figure 5.30) was taken at the same time. It shows a more detailed view of the gallery and indicates that it had been paved with brick.

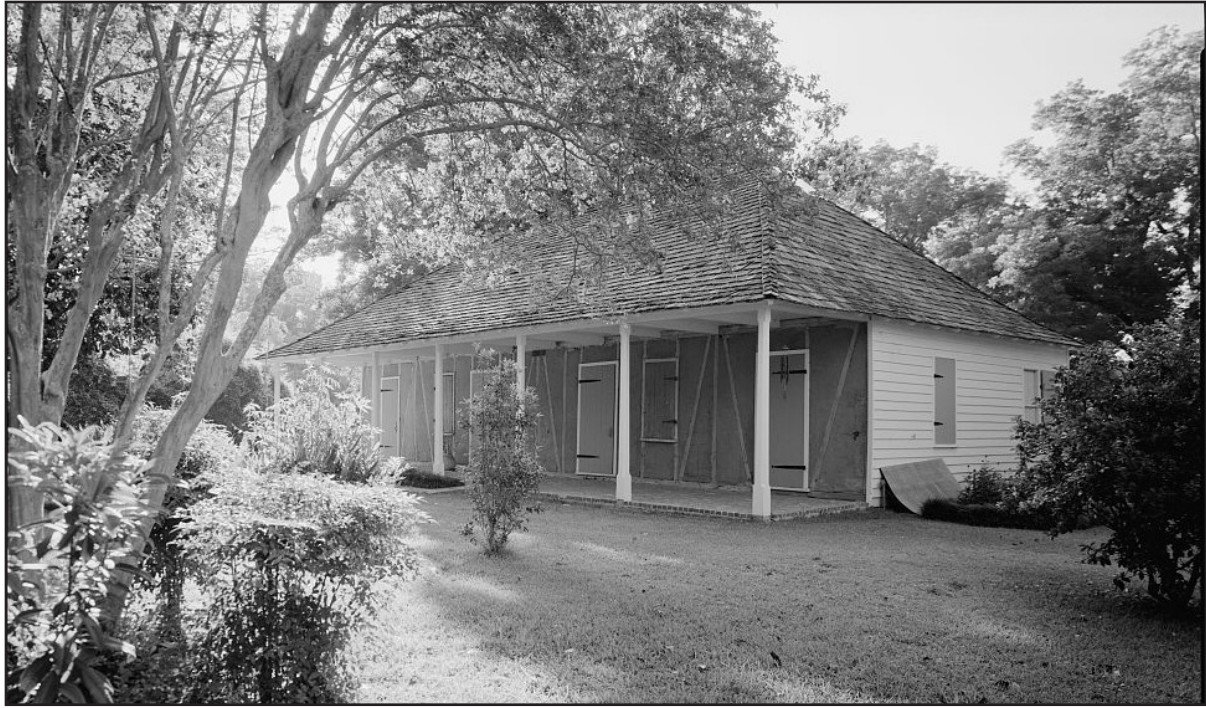
Figure 5.38. (Above) A 1980 Historic American Buildings Survey photograph showing the front and eastern side of Yucca House after the Wilson and Koch restoration (Library of Congress, Historic American Buildings Survey, LA-2 -69-A-3).

A series of photographs of Yucca House were taken in 1980 shortly after its restoration was completed. One of these (Figure 5.38) shows the front and eastern side of the building. The two former double-leaf doors exiting the two smaller rooms on the eastern end of the structure had been replaced with windows having single-leaf board-and-batten shutters hung by large strap hinges. The flooring of the gallery was then basket-weave brick laid on top of a concrete slab. The former gallery posts made from the trunks of small trees had been replaced by champhered wooden posts. Single-leaf board-and-batten doors supported by long strap hinges had been installed where wooden interior doors and exterior screened doors formerly hung. None of the *bousillage* walls along the gallery were painted, though the front columns, ceiling joists, ceiling decking, and eastern exterior walls had been painted white.

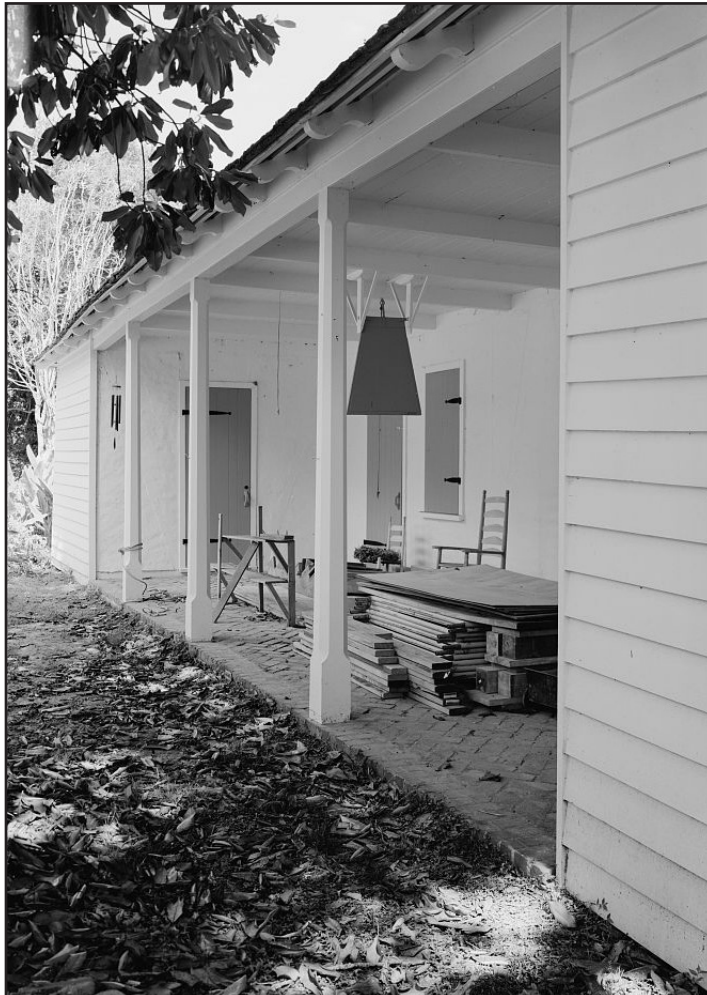
Figure 5.39. (Left) A 1980 Historic American Buildings Survey photograph showing the rear of Yucca House after the Wilson and Koch restoration (Library of Congress, Historic American Buildings Survey, LA-2 -69-A-7).

In viewing the photograph of the rear of the house (Figure 5.39), it is clearly seen that decorative rafter end treatments, an element not seen on any of the historic images of this house, had been added. Here, again, the flooring of the *loggia* was basket-weave

brick laid on a concrete slab. Three chamfered wooden columns supported the roof along the front of the *loggia*. The double louvered doors on the north walls of the two cabinets had been removed. All door and window openings were covered by single-leaf board-and-batten doors or shutters.
